THEA FOSS AND WHEELER-OSGOOD WATERWAYS REMEDIATION PROJECT

YEAR 12 MONITORING

HABITAT MITIGATION AREA AND SLOPE REHABILITATION AREA PRELIMINARY FINDINGS MEMORANDUM

AUGUST 23, 2018

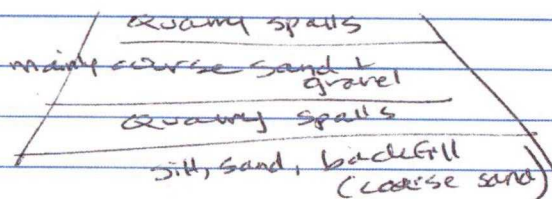
Transition is slope composition - rip rap with sand in between
on upper slope. on very upper
portion of slope some pilings sticking
up through rip rap. Lower portion of
slope - mix of coarse sand, gravel,
some silt, shell debris.

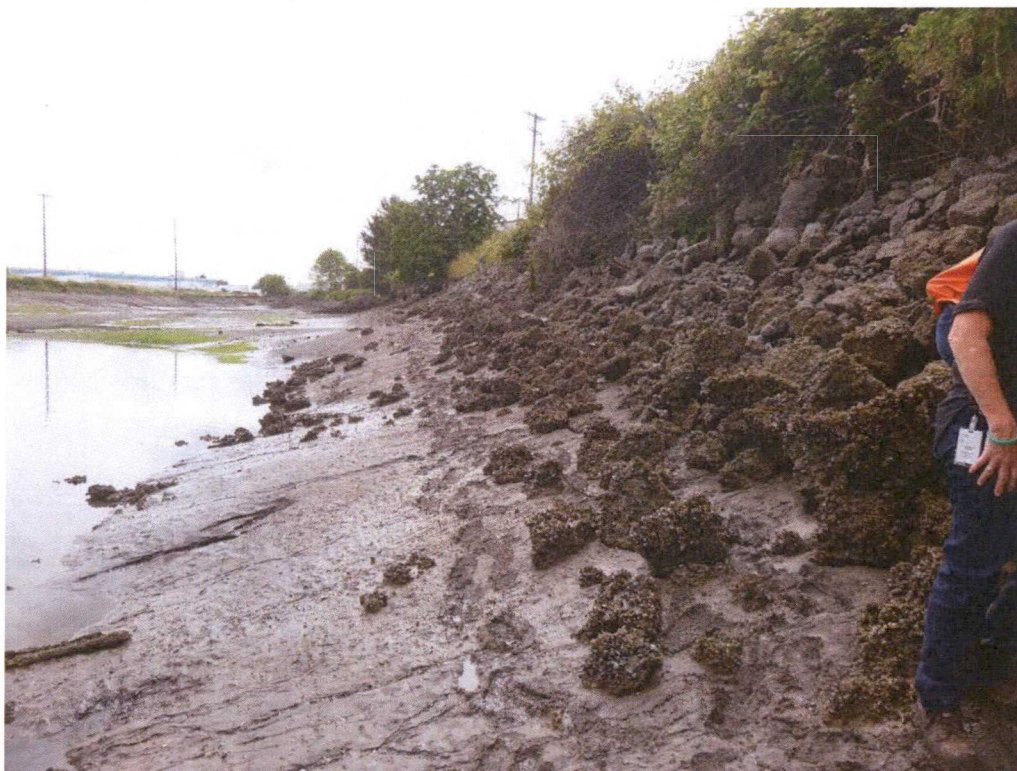
Year 12_RA-11_P1020438

Piling ends were observed near the top of the slope throughout the RA 11 slope rehabilitation area.
